MPTA-C8c-2011

## Sleeved Element Failure Analysis

MPTA Information Bulletin

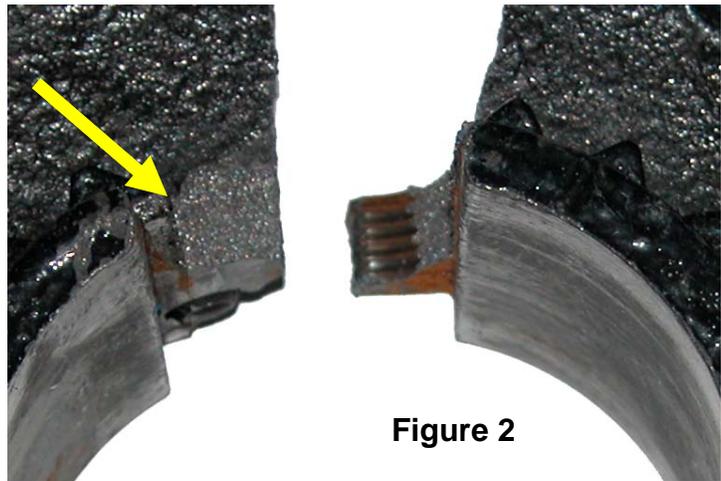
Figure 2

A keyway burst failure can be caused by two possible situations. The first is due to the hub being subjected to an over torque condition. The weakest point in the hub is usually over the top of the keyway where there is the smallest cross section of material between the top of the keyway and the outside diameter of the hub. This is where an overload fracture is most likely to originate (see figure 2).

The second condition where this can occur is when a hub is forced onto a shaft in an interference fit condition or the key is too large. The pressure from this interference fit will cause the hub to burst at the weakest point which is typically at one of the top corners of the keyway.

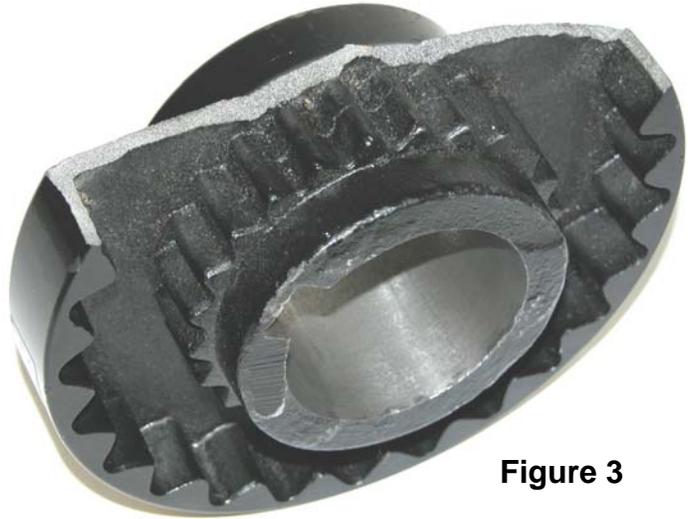
**Figure 3**

A common reason a fracture might occur across the face of a flange outside the hub area may be attributed to a material defect in a casting due to inclusions that are not present in powder metal construction. A second common cause for this type of failure occurs when the flange is subjected to improper installation practices with installation abuse. Use of improper, or abusive techniques during installation, such as aggressive hammering can cause cracks in the face of the flange.

These cracks can fracture during the installation as can be seen in figure 3 or in the presence of any sizable load when placed into operation.

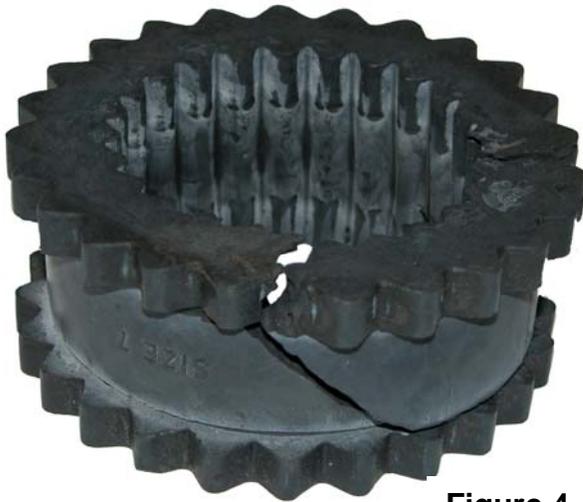
**Figure 4**

When the elastomeric sleeves is subjected to an excessive load where the torque exceeds the ability of the sleeve to twist, or wind-up, the sleeve will fail or tear in a classical diagonal pattern as shown in figures 4 and 5 as a result of a torque overload. The sleeves are designed to operate with a certain level of wind-up and when the

sleeve fractures it takes on a diagonal orientation due to the wind-up. This wind-up can be as much as 7° for Hytrel sleeves and 14° for EPDM rubber and Neoprene sleeves.

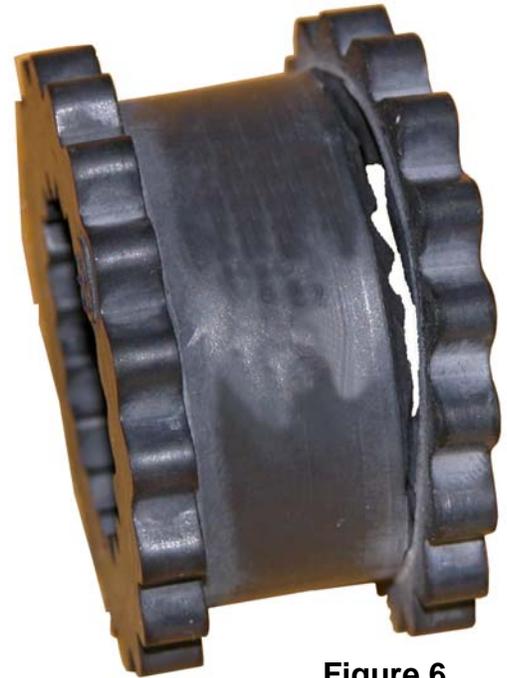
Figure 6

Straight tear failures (see figure 6) typically occur along a stress line between the serrations and the center section of the sleeve. These are often caused by material defects created during the mold process of the sleeve. This particular defect is usually noticeable when installing the sleeve.

This type of failure can also occur as the result of fatigue from misalignment, particularly when the hubs are pressed too tightly together against the sleeve during installation. Usually the brake occurs completely across the sleeve prior to detection. The sleeve in figure 6 was caught early prior to complete separation.

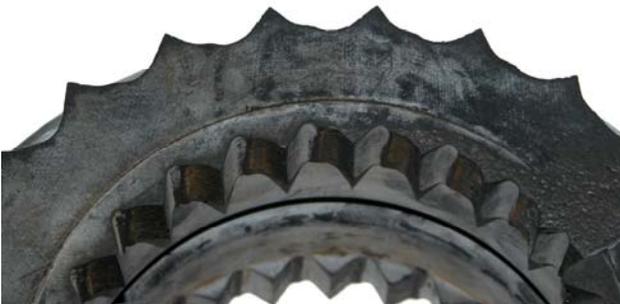
Figure 7

When the serrations on the elastomeric sleeves are allowed to slide inside the flanges, the serrations literally grind off. See figure 7. If the wear is not detected relatively early, the serrations will wear off completely as in figure 9.

The elastomeric sleeve coupling is designed to operate with some degree of wind-up which places pressure between the serrations on the sleeve and the serrations in the flange. Compensation for misalignment takes place through the stretching of the elastomer, however, when the amount of misalignment exceeds the ability of the sleeve to stretch, the elastomer slides inside the serrations of the flange. This sliding action wears away the elastomer material until the serrations are compromised to the extent they spin inside the flange and no longer transmit any torque. Often the material that wears off builds up under the coupling guard.

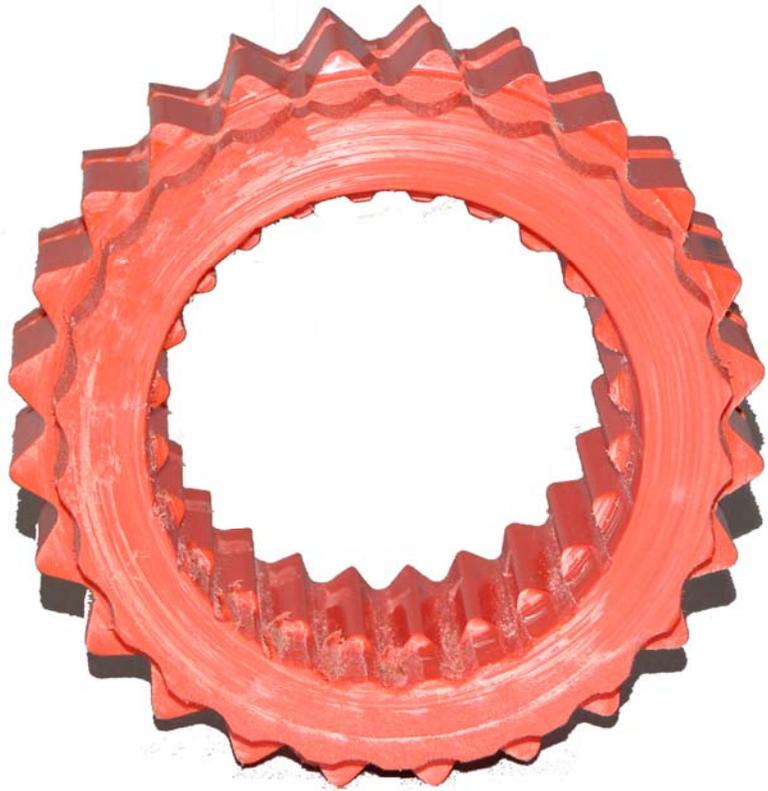
**Figure 9**

The elastomeric sleeve coupling is designed to operate with some degree of wind-up which creates pressure between the serrations on the sleeve and the serrations in the flange. When this wind-up pressure is not adequate to maintain a non sliding surface, 'chatter', or rubbing occurs that wears away at the serrations on the sleeve. This 'chatter' can often be heard while the coupling is in operation and can be difficult to differentiate from the wearing noise generated due to misalignment. Wear patterns appear similar to the wear shown in figure 7 and figure 9. If the wear is not detected soon enough, the serrations can wear completely off the sleeve, usually only on one end, and the sleeve will spin freely inside the flange.
