Common Causes of Grid Coupling Failures

Informational Bulletin

This Informational Bulletin presents recommendations for identifying common causes of grid coupling wear and failures.

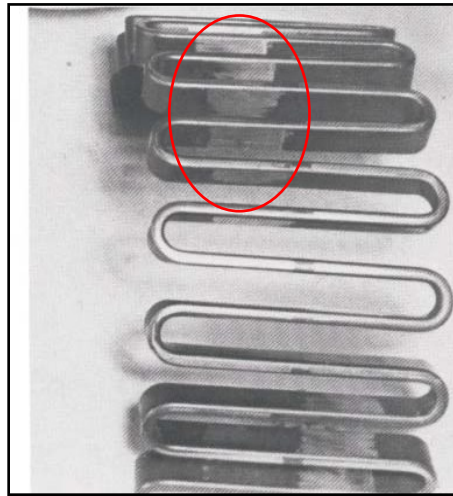
Fig 1

A Grid coupling accommodates misalignment by the sliding and flexing of the grid in the hub tooth slots; this action, provided with proper lubrication, develops a polished surface on the grid to hub contacting surfaces. An example of normal grid wear is shown (Fig 1).

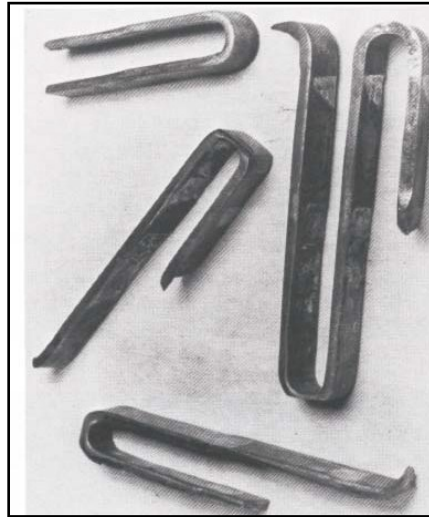
Fig 2

With inadequate lubrication, grid wear will be accelerated in the following stages:

- Early stage: Contact area of grid will appear scuffed
- Middle stage: Deeper grid wear areas with fretting corrosion (red powder)
- Late stage: Cross section of grid worn to point of grid breakage (Fig 2).

Grid wear is accelerated further with increasing misalignment which serves to increase the sliding action and loading of the grid.

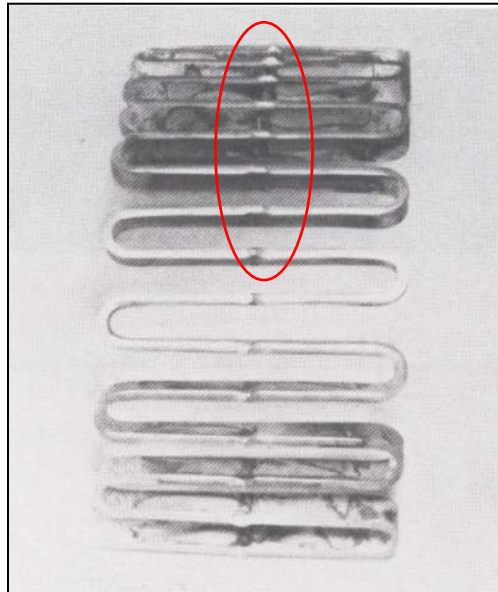
Fig 3

A combination of grid end wear and wear on radially outer edge of grid where it strikes the inside of cover are indications of excessive shaft misalignment (Fig 3). Higher speeds will increase the severity of wear. In general, excessive grid wear conditions can be minimized with good alignment and proper lubrication.

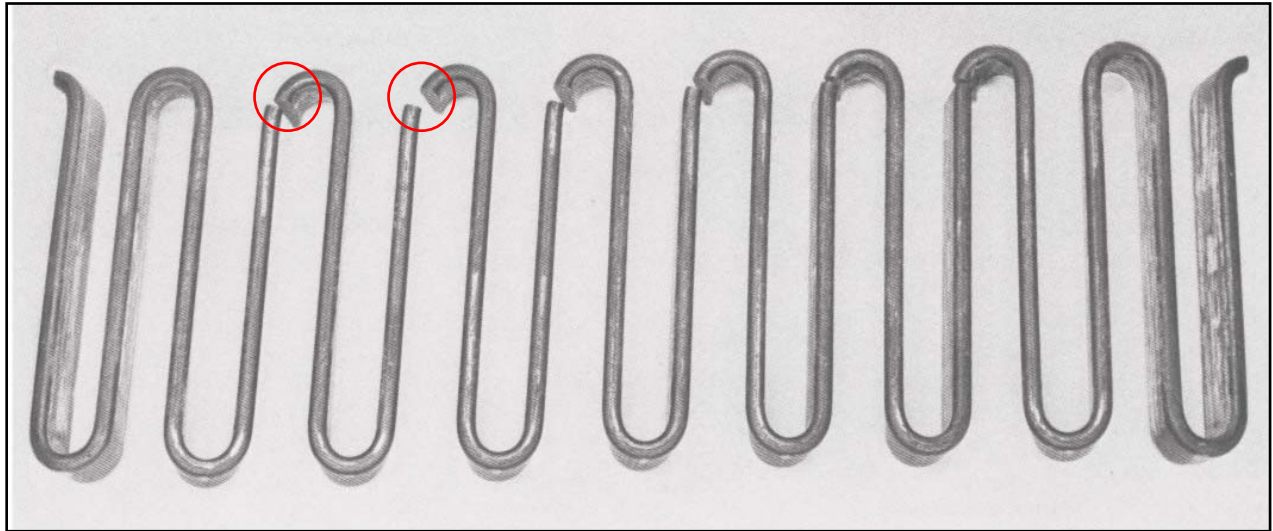
Fig 4

The flexible grid member flexes to transmit torque and accommodate misalignment. In this cyclic type loading, if the allowable bending fatigue stress of the grid is exceeded, a fatigue type failure will occur. These cyclic load changes may consist of a complete or partial reversal of torque (+ to -) or may vary within the same load direction (0 to +).

The location of the grid fracture on the grid along with the number of load cycles before failure can help determine the failure load. Load cycles could be the frequency of a vibratory load, the number of starts, speed changes, or in the case of misalignment, the RPM of the coupling.

A grid failure occurring between the hub tooth contact point and grid loop or in the loop of the grid generally indicates a high cycle low load fatigue failure (Fig. 4).

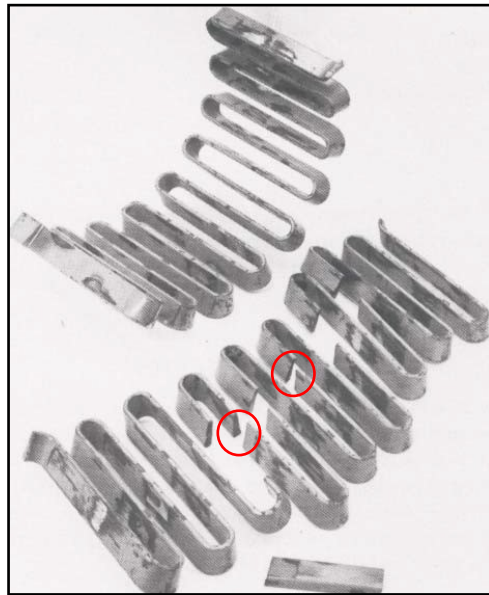
Fig 5

Grid failures caused by low cycle fatigue are a result of excessive torque, misalignment, or a combination of the two. Examples of excessive torque situations are high inertia starts, high braking torque or high shock loads. Grid failures can be prevented by improving the coupling alignment, removing the overload condition or selecting a coupling size which has the capacity to handle these loads. When grid failure occurs between tooth contact point and the coupling hub gap this generally indicates a low cycle high load fatigue failure (Fig 5).

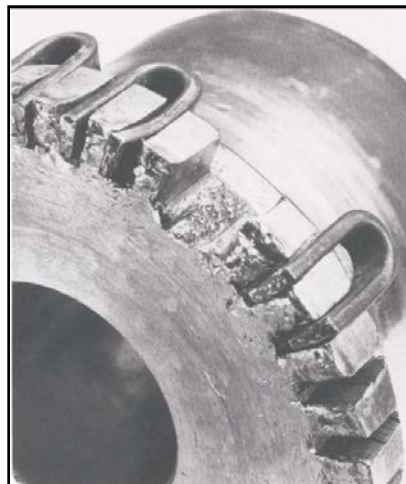
Fig 6

Under extremely high peak loads, the grid section may fracture in the gap portion of the coupling and be accompanied by broken and deformed hub teeth. This type of grid coupling failure is very infrequent (Fig 6).

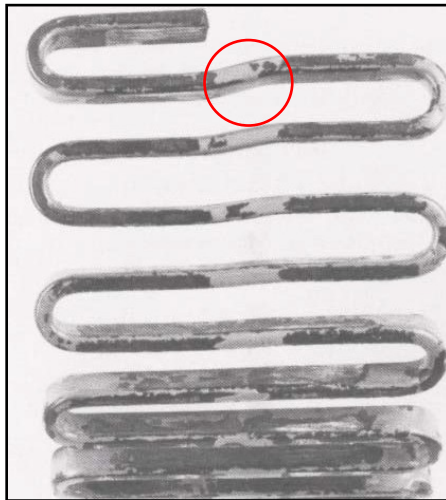
Fig 7

A grid yield failure without fracture can also occur in the gap area of grid (Fig 7). Grid yielding in the coupling gap area can be prevented by removing system overloads and realigning equipment.

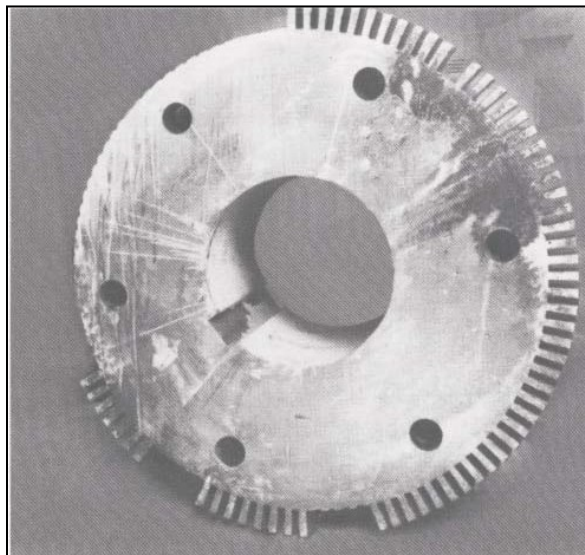
Fig 8

Grid coupling hub teeth are designed to have much higher fatigue strength than the grid; as a result, hub tooth fatigue failures are rare with grid couplings. In very extreme shock or high peak conditions, it is possible to deform and break teeth along with the grid segments. As a result of overload and misalignment the hub teeth may break at the root diameter (Fig 8).

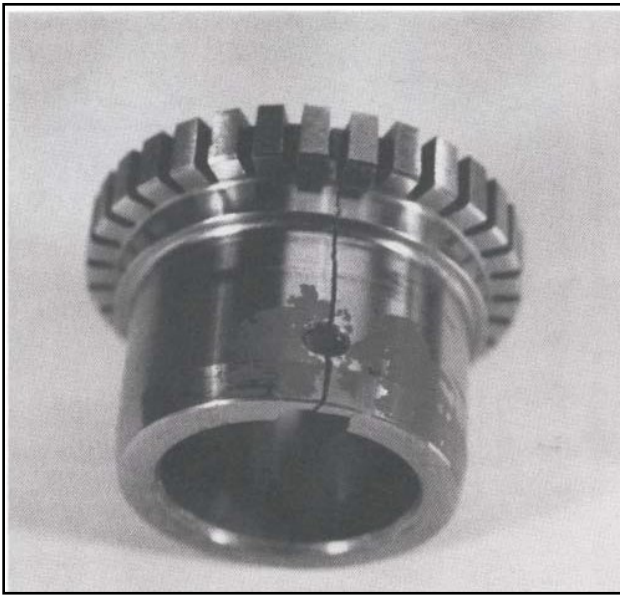
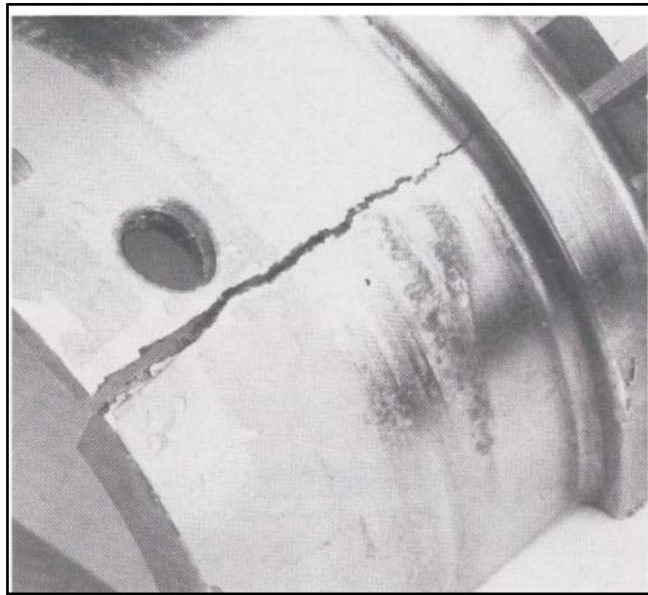
Occasionally a grid coupling hub shoulder failure is encountered. These failures generally consist of cracks extending through the hub shoulder at a keyway corner or through the set screw hole (Fig 9 & Fig10). Grid hub failures can usually be traced to poor installation

Practices, such as hubs forced onto shaft radii, keys oversize for hub or shaft keyways, setscrews being tightened on hot hubs used for interference fits, or excessive interference fit between shaft and hub.

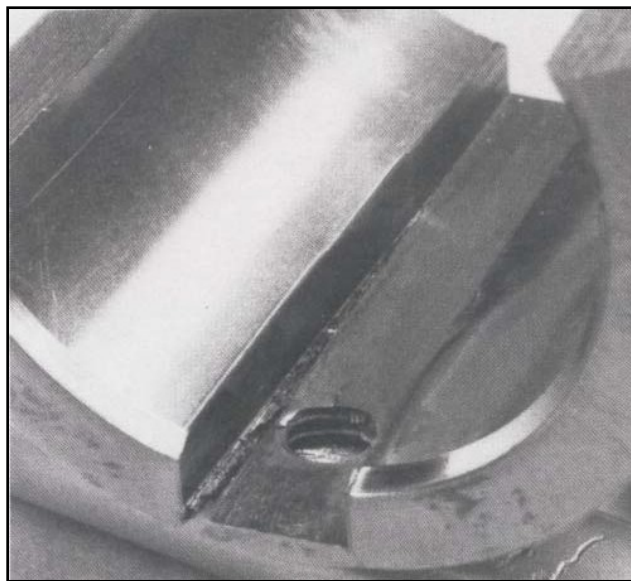
Fig 11

Sometimes a short length of key engagement into the hub may cause local yielding in the keyway (Fig 11). The resulting loose key may initiate hub failure due to high loading stresses. This is most commonly seen in smaller size couplings where clearance fit hubs are preferred by most customers.

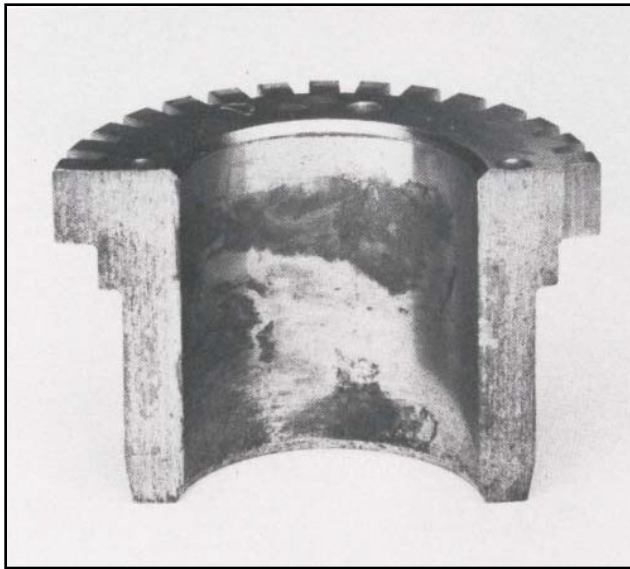
Fig 12

The cause of hub bore wear and fretting is usually from clearance between the hub and the shaft which permits axial or planetary motion (Fig 12). Clearance fit hubs having loose setscrews may also permit sliding or rocking of hubs; in these cases, the hub tooth face and the contacting grid surface of loose hub will often show excessive wear. Hub movements are related to external forces such as increased bearing clearances, flexible foundations, loose equipment, or excess shaft deflection. Hub failures can frequently be prevented with good maintenance practices. The bore, key, hub and shaft keyway fits need to be correct, setscrews properly torqued and external components such as bearings and supporting foundations must be operating within acceptable limits.

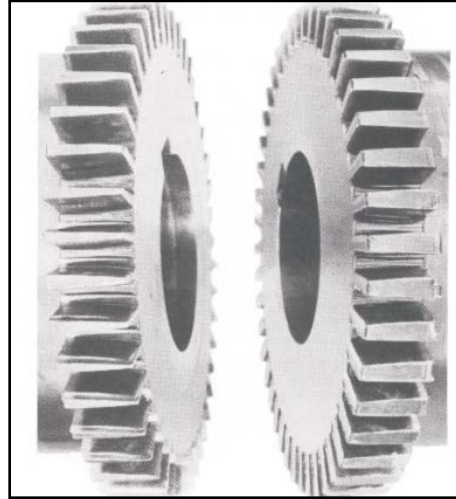
Fig 13

Hub teeth will wear from the sliding action induced by misalignment that is combined with the tooth loading from torque transmission. This wear is greatly accelerated by lack of or improper lubrication (Fig 13). Improvements in alignment and lubrication practices, will reduce hub tooth (and grid) wear.

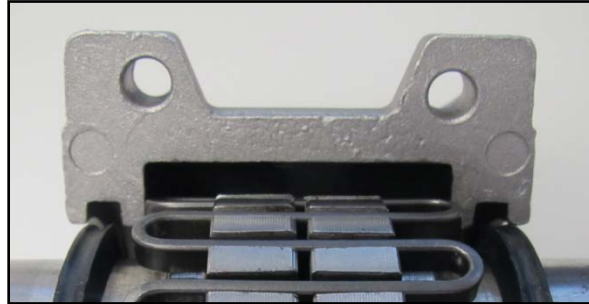
Fig 14

The seal used with the horizontal split cover design, is placed into position on the hub before the cover is placed on the coupling (Fig 14). If the hub barrel outer surface is dry, rusted, or scratched, this seal may roll over in assembly of the cover and create an unsealed condition. Lightly lubricating the hub barrel and seal before assembly helps improve seal performance, eases coupling assembly and helps prevent seal failure.

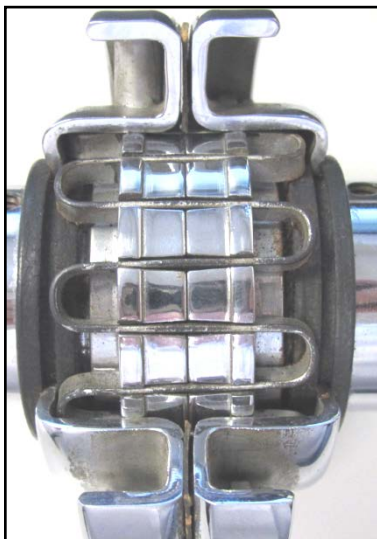
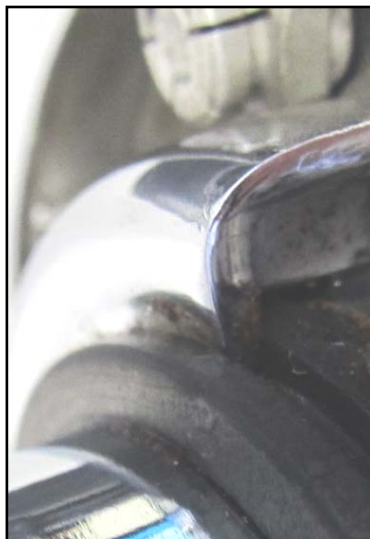
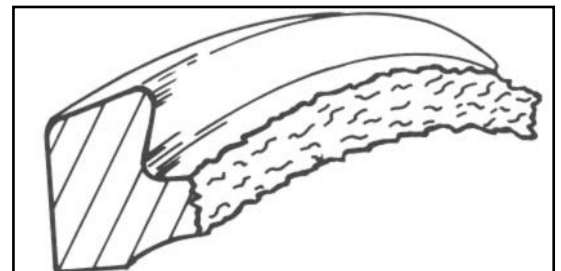
Grid couplings that use a vertically split cover design have seals that fits over the inside diameter of the cover seal flange (Fig 15 & Fig 16). If the hub barrel outer surface is dry, rusted, or scratched, this seal may roll over in assembly of the cover and cause the seal to come off the cover flange. To minimize seal roll over, lightly lubricate the seal and hub shoulder to permit the seal to slide freely until the half cover is assembled in place. The seal may also be cut due to excessive misalignment (Fig 17). Improving equipment alignment will eliminate this problem.

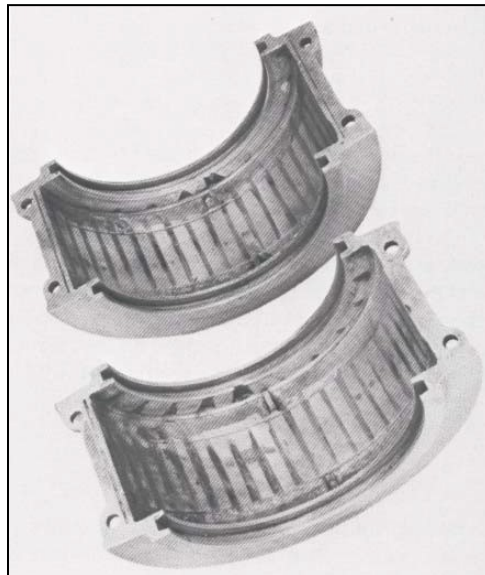
Fig 18

Since the cover must retain the grid both axially and radially, it is normal to find markings or shallow grooves in the inside of cover. Deep grooves (Fig 18) indicate coupling is operating with excessive parallel misalignment. Since the cover carries no loads, such markings on the inside of cover will not affect the torque transmitting ability of the coupling. Correcting the misalignment will extend the life of the load carrying components.

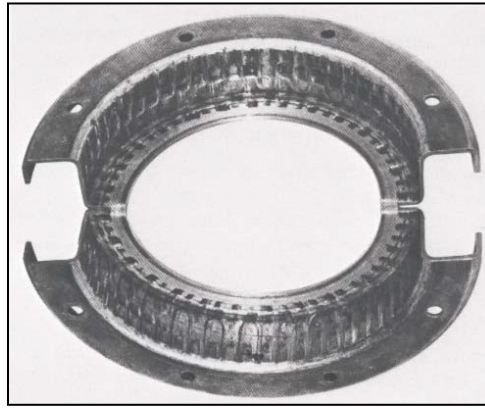
Fig 19

The inside end faces of the covers may have indentations from grid loop contact. These markings are normal and only a concern if their depth approaches one-half of the side wall thickness (Fig 19).

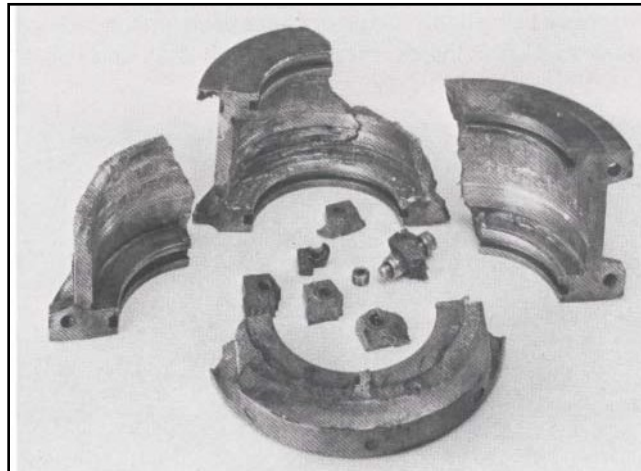
Fig 20

On rare occasions, covers can fracture. If the coupling is subjected to repeated high loads that result in grid failures of every rung near the gap, this allows the driving hub to turn independent of driven hub and the cover rotates with the driving hub until grid pieces became wedged between the stationary hub and rotating cover, resulting in destruction of the cover (Fig. 20).
