MPTA-C7c-2010

Common Causes of Tire Coupling Failures

INFORMATIONAL BULLETIN

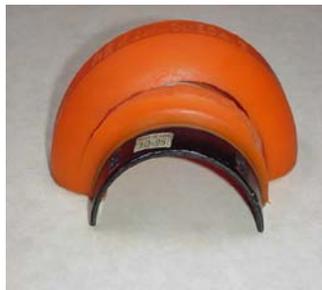
2.1 Fatigue in Urethane

Fatigue in urethane-based elastomers is evidenced by a tear of the element thru the sidewall just above the bonded area. This tear is typically gradual. The failure propagates from the end of the element thru the stress relief depressions at the split. These failures can be detected early with visual inspection by observing the initial crack/tear of the coupling ends. The most common cause of fatigue failure is influenced by misalignment.

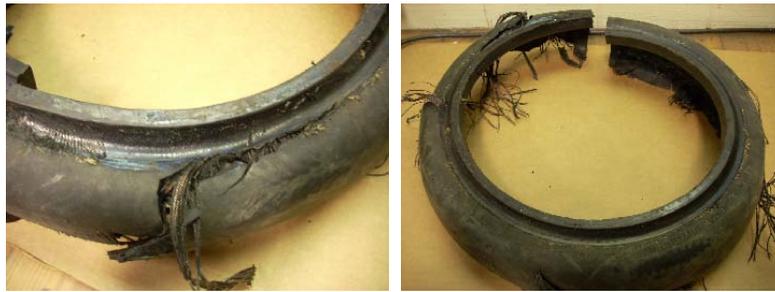
2.2 Fatigue in Rubber

Fatigue in rubber-based elastomers is evidenced by cracks in the region of the element split. However, the primary fatigue damage is evidenced by large cracks located slightly above the clamp circle. These cracks extend completely through the element and often radially over the outside diameter of the element. As the cracks propagate, rubber debris, often similar to coffee grounds, will be evident beneath the coupling. Replacement is recommended when cracks extend for 20% or more

of the element circumference. If the element is not replaced the cracks will continue to propagate and the reinforcement fabric will become torn and exposed. The fabric strands are often extended and bare.

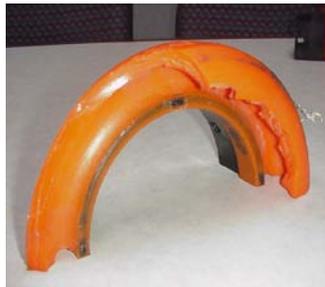
3.1 Overload/Shock load in Urethane

Evidence of a jagged tear starting in the sidewall and propagating toward the OD reflects overload and/or shock loading conditions. The shock loads cause the jagged tears in the sidewall. When the failure cuts upward into the top section of the element, the coupling is in pure overload. In pure overload, the element tears down the center; the elements thinnest section with the highest stresses. Extreme overload failures exceeding 500% of the coupling rating is reflected by a glassy, smooth surface.

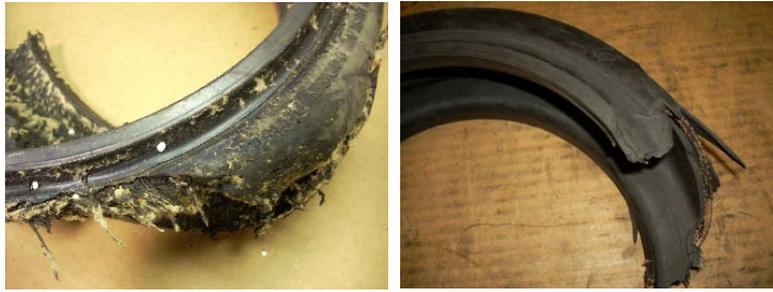
3.2 Overload/Shock load on Rubber

Overload and shock load conditions with rubber-based elements are also evidenced with jagged wear patterns with the rubber. The cording that is exposed is typically torn relatively close to the edge of the rubber; shorter fabric length exposure than with a fatigue failure. 45° tear propagation from the shaft centerline is also evidenced from the initial jagged tears.

Overloads will often cause the element to slip between the hub and clamp ring, however, this condition is also representative of improper installation.

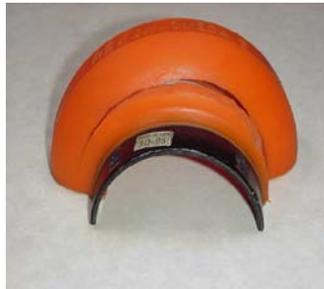
4.1 Misalignment in Urethane

Misalignment in urethane-based elements is often evidenced by a bond failure of the element to the hub. Cracks may also form on the element sidewall. Evidence of failure from misalignment is often equivalent to that of fatigue failure.

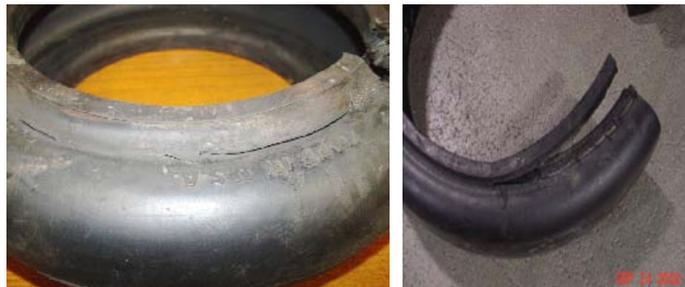
4.2 Misalignment in Rubber

Angular misalignment in rubber is usually represented by cracks above the clamp ring. These cracks and tears on the exterior sidewall that do not propagate angularly are indications of angular misalignment. Cracks that propagate radially, similar to early onset fatigue failure, represent parallel misalignment. Cracks on the interior surface of the element above the internal clamp ring are indicative of excessive end float.

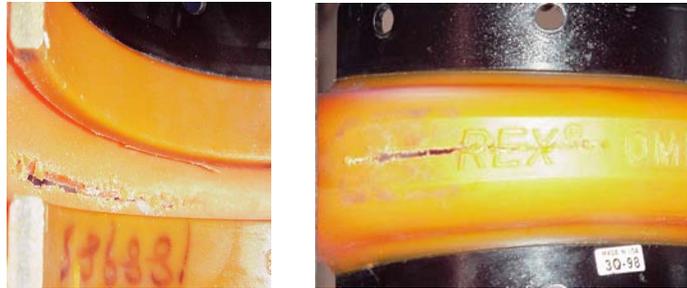
5.1 Hysteresis in Urethane

Hysteresis in urethane occurs when the urethane absorbs torsional vibration from high frequency pulsations. In dampening these vibrations, it converts the energy to heat. If the frequency is high enough the urethane cannot dissipate the heat fast enough and the urethane temperature continues to rise until it melts. The urethane temperature rises until it melts and liquefies. The failure usually occurs in the center of the coupling where there is less conductive surface to dissipate the heat. The shape of the tear is usually serrated and will be accompanied by molten urethane that appears in the underside of the coupling similar to a melted candle wax.

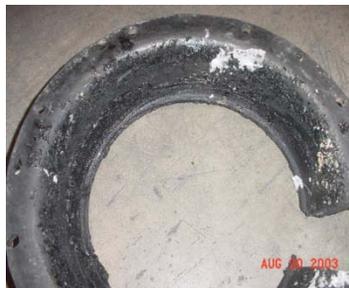
5.2 Hysteresis in Rubber

Hysteresis in rubber-based elements is less common due to its higher levels of conductivity and temperature capability. However, when the effects of vibration are high enough, the rubber will begin to locally revert toward its initial natural rubber properties prior to vulcanization. This results in extremely soft and/or tacky rubber.

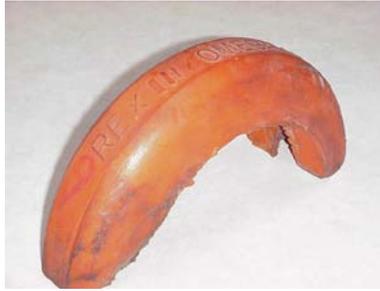
6.1 Hydrolysis in Urethane

Hydrolysis in urethane occurs as degradation at the bond where fatigue stresses are the highest. The mode of failure can be verified by an awl test or sliver test. Both tests identify basic degradation in the element's elasticity of the urethane. Contact the element manufacturer for details.

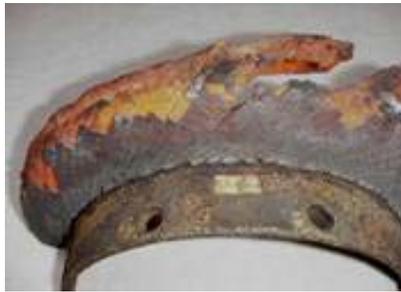
6.2 Chemical Attack in Urethane

Chemical attack in urethane is characterized by discoloration, increased stiffness, brittleness and cracking in the urethane or corrosion of the metal. Striated layered cracking or "alligator skinning" of the urethane is a conclusive sign of chemical attack. If unsure of the chemical resistance of the urethane, consult the manufacturer for a detailed listing of urethane chemical compatibility. Alternative urethanes may be available to improve performance.

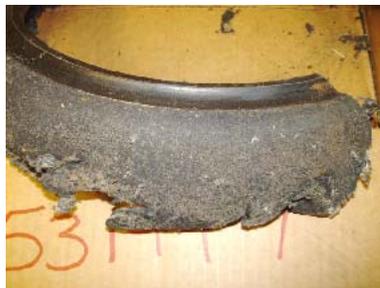
6.3 Chemical Attack in Rubber

Chemical attack in rubber is evidenced by degradation in geometry, finish and/or surface hardness of the rubber. The effect is related to the type and concentration of the chemical. Contact the coupling manufacturer for information regarding the chemical resistance of the rubber. Alternative elastomers may be available to improve performance.
