MPTA-C8c-2011

## Sleeved Element Failure Analysis

MPTA Information Bulletin

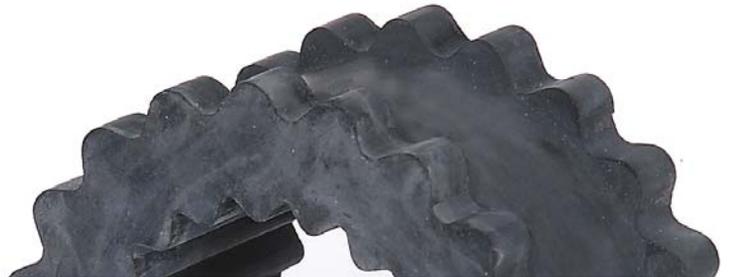
Figure 8 shows a new sleeve with normal serrations as should appear on any sleeve prior to that sleeve being installed in a coupling.
